# **INTEGRATING PATH TECHNOLOGIES INTO MILITARY FAMILY HOUSING**

**Status Report on Housing at Beaufort/Parris Island, SC**

**April 2006**

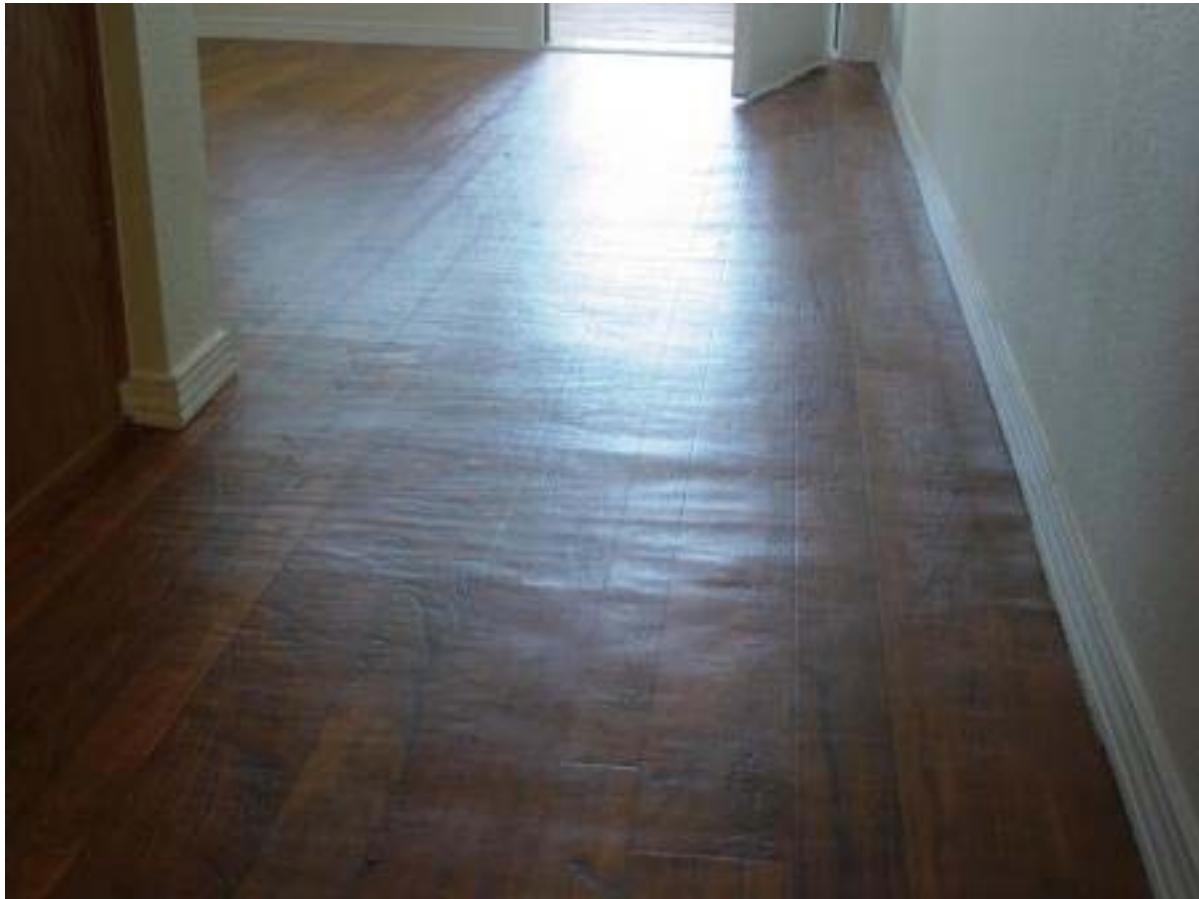
A Newport representative participated in a site visit in August 2005 to help identify the moisture issues and potential solutions. Others who participated included the project architect and management and site personnel from Actus Lend Lease. The focus of the visit was on problems that were occurring with buckling floors of homes as shown in Figure 2.

Figure 2 – Buckled floor at Parris Island home.

- Condensation is occurring on the bottom of the first floor system above the batt insulation in the homes with floor buckling. This has resulted in visible mold and increased moisture near the top of the floor joists and in and on the OSB. Although it is possible that some of the high moisture in the materials is the result of exposure during construction, no evidence was found to support or dispute this possibility.

- OSB moisture contents in areas under vinyl floors were above 40% in two of the homes. The carpet may be partially mitigating the impact, since moisture content of the OSB was in the low to mid 20s (%) under carpeted areas. This may be due to the R-value added by the carpet and pad, or the higher permeability of the carpet relative to the vinyl floors is letting moisture pass through into the interior where it is removed by the air conditioning (AC) system.

The field observations, literature, and our consultation with moisture experts point to the floor system being cooled for extended periods of time to below the dew point temperature and causing the warm, humid outdoor air to condense on the underside of the floor. It is likely that the carpeted areas are helping to mitigate the problem somewhat because they are permitting moisture vapor to pass through into the home, where the AC system removes it. Another possibility is that the R-value of the carpet and pad, although generally small, is just high enough to isolate the OSB sub-flooring from the colder indoor air, at least for extended periods of time.

- Raise the thermostats to at least 76°F in all of the buildings to prevent the floors from being cooled to below the dew point. This should be implemented immediately and throughout the life of the buildings. Supplemental dehumidification may make this a more practical option since it would result in more comfortable conditions at the higher indoor temperatures.

- For homes yet to be built or under construction, consider using spray foam insulation under the floors to push the dew point away from the OSB. With the current batt insulation, air can easily move into the floor cavity between the joists. There are also some pros and cons to using a closed or open cell foam. Each can provide a thermal barrier between the OSB and the colder inside air. Likewise, each will reduce or eliminate air movement compared to batt insulation. Closed cell materials offer a better vapor barrier but you want to make sure the materials are dry so you don't trap moisture in the floor assembly. An open cell material will provide equivalent separation of the cooled floor from outside air, but it is not as robust of a vapor barrier.

- For the homes already built, the only solution for areas that are severely damaged due to high moisture levels in the materials is to remove the damaged areas and rebuild them with appropriate methods to prevent the problem from re-occurring. Most guidance suggests removing the material at least two feet beyond the damaged areas. We consulted with the American Forest and Paper Association's representative for the southeast United States region on whether there will be permanent damage to the OSB. Generally, if OSB or dimensioned lumber has not lost any material due to the presence of

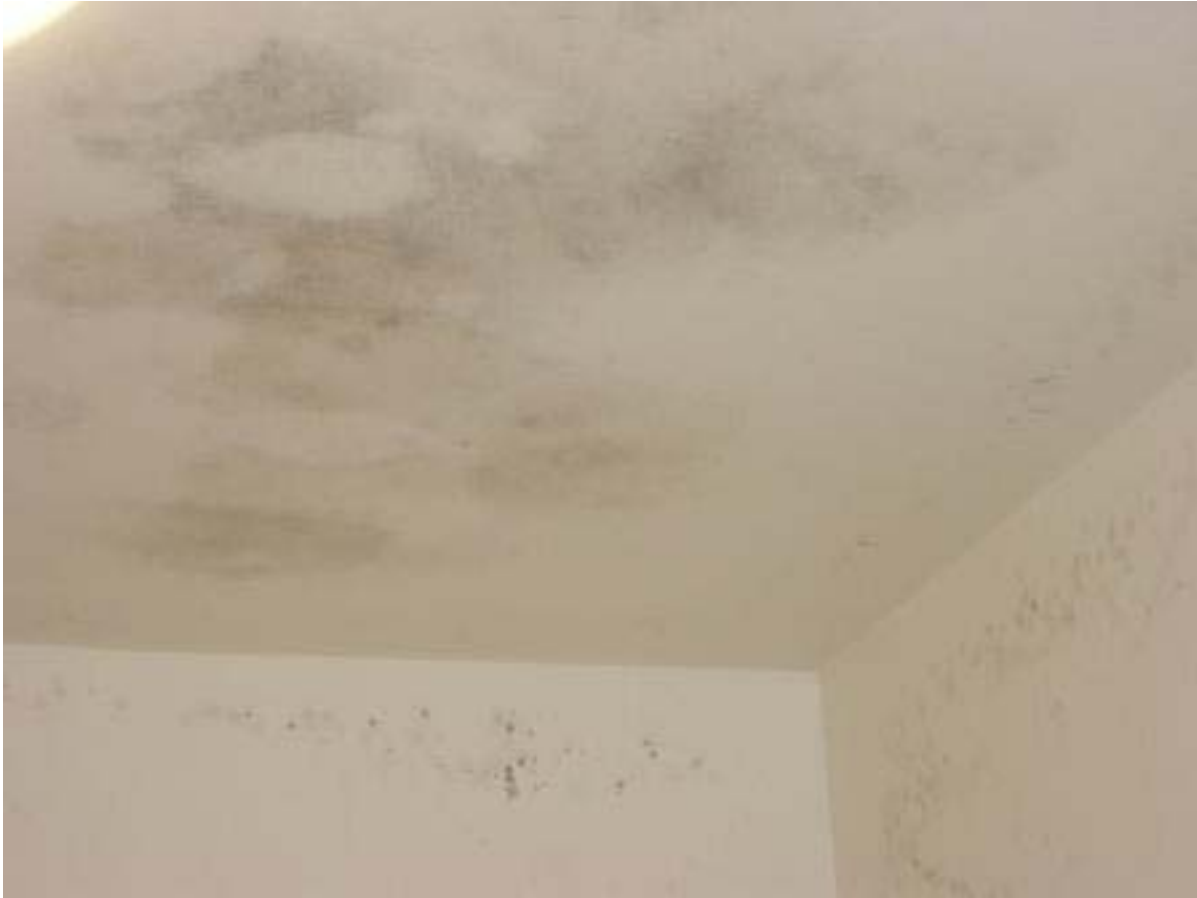
- Observations and measurements did not positively identify a source of the elevated relative humidity in the bathrooms with visible mold problems. Moisture that migrates into the homes due to the condensation on the raised floor systems is a likely source. However, independent of the source, the air movement into or out of the baths that have visible mold problems is inadequate to remove moisture or any other potential pollutants.

This type of problem was initially uncovered in a single home when an occupant returned after several weeks away and reported mold on the ceiling and upper level of walls in the second story bath off of the main hallway (see Figure 3). This problem was thought to exist only in one home that also had the floor buckling problem. Further exploration indicated that it is occurring in other homes and is likely related to a number of factors working together including the moisture condensing on the underside of the first floor sheathing.

Figure 3 – Visible mold on ceiling and top of walls in bath.

The baths in question are located on the interiors of the second floor and do not contain any windows. One could spend considerable time trying to diagnose the issues surrounding air and vapor movement and whether the floor problems are contributing excess moisture load to the bathrooms, but the bottom line seems to be that there is not enough of an air exchange for the baths to keep the moisture levels down regardless of the source(s). Options to address this include:

- Increase the flow into these rooms and consider running the HVAC air handler continuously, although this would induce a minor energy penalty.
- Upsize the fans to exhaust more air from the bath to the outdoors.
- Change from separate switches for the fan and light to one switch that turns the fan on when the light is turned on. However, this may not solve the problem if the occupants do not use the room frequently.
- Install a quiet (low sone), higher capacity, continuous operating fan or a humidity-sensor controlled fan and take the occupants out of the equation altogether.

We recommended that the designer or architect of record consider these options in all of the new homes under construction and for retrofit of problem homes.

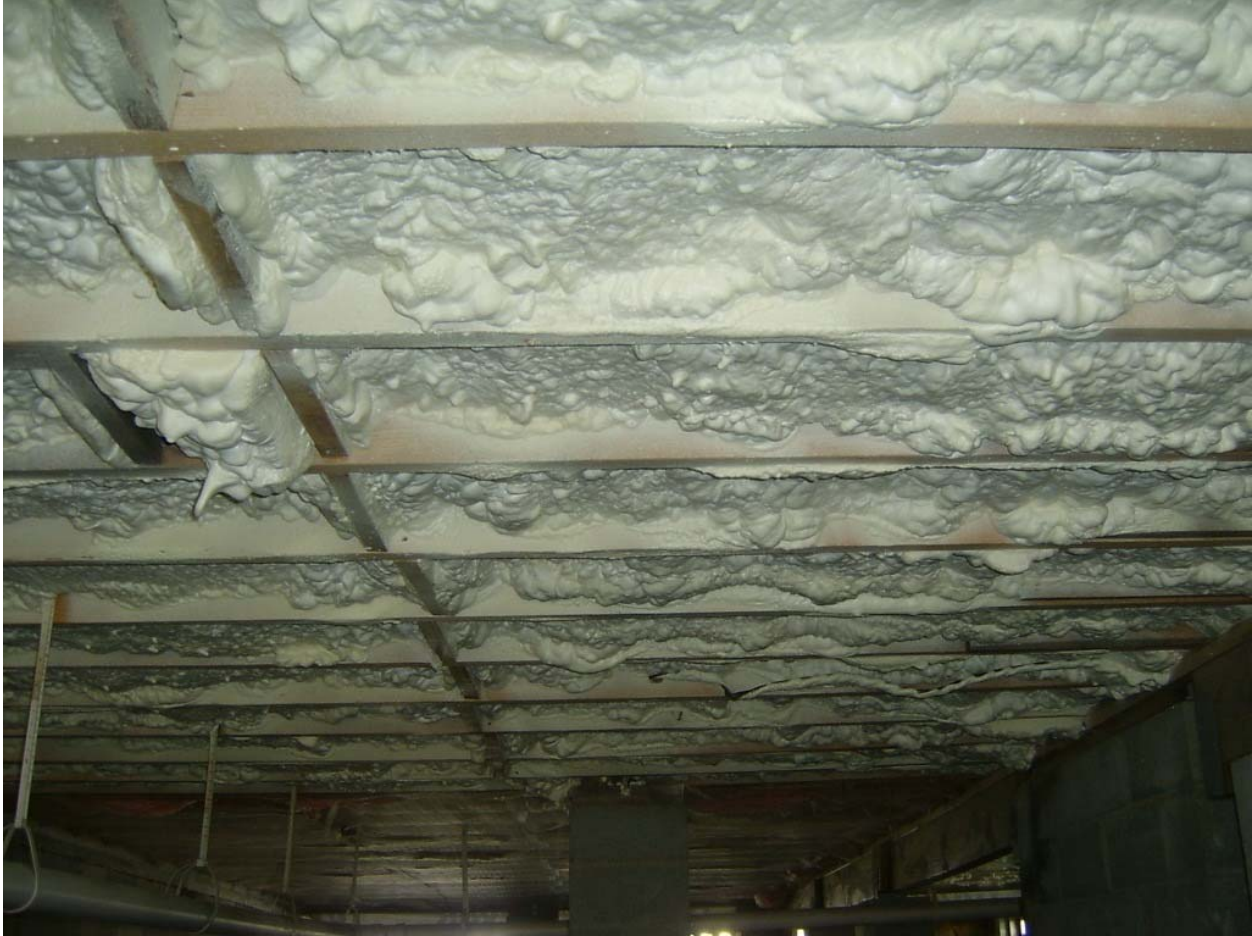
Figure 4 – Icynene insulation between joists of raised floor system.

Throughout the month of March 2006, Actus began work to mitigate the moisture problems in the homes. The mitigation strategy relies heavily on the recommendations from our assessments, including the key step to isolate the floor from the exterior through the use of spray-in foam insulation. Actus elected to go with Icynene, an open cell product, because they believe it will be more forgiving should some moisture get into the joist cavities.

- Portions of carpets, vinyl, and subflooring were removed and replaced on 35 homes that had elevated moisture and damage to the OSB.
- On about 80 homes, including the 35 that had parts of the floors replaced, the batt insulation in the floors was removed and the OSB was permitted to dry to below 19% moisture content.
- A mold remediation company was used to treat the underside of the floor deck and the joists as necessary.
- After the drying was complete, Icynene was sprayed into the cavity of the floor joists (See Figure 4).
- All of the lots are being re-graded to make certain that water does not pool under or around the foundations.
