LABORATORY AND FIELD EVALUATION OF PAN FLASHING/SILL PROTECTION AND WATER RESISTIVE BARRIERS

FINAL REPORT

April 2006

Williams Building Diagnostics, Inc.
945 Tennis Avenue
Maple Glen, PA 19002

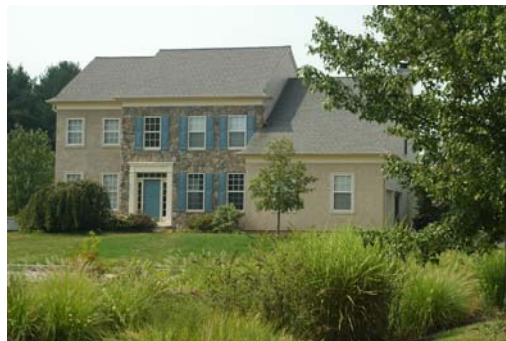
Figure 3. Field Investigation. Single-family Residence in Ambler, PA

In 2004, the homeowner reported water intrusion near some of the home's windows. During the course of corrective repairs, contractors found additional evidence of water intrusion, entrapment, and material deterioration in the exterior wall.

The sheathing had moderate to severe deterioration originating primarily at window corners. Moisture-related damage occurred below many windows, most notably on those at the first floor level, where rot had damaged the sheathing and some of the wood wall and floor structural members beneath the windows.

- Replaced deteriorated exterior sheathing and framing components;
- Installed a new WRB layer over the sheathing, and integrated it with rough opening flashings; secured the edges of the WRB with fasteners and then wrapped it with SAM;

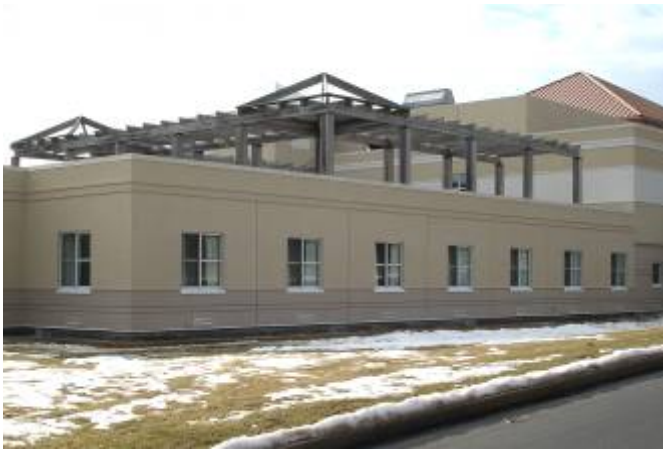
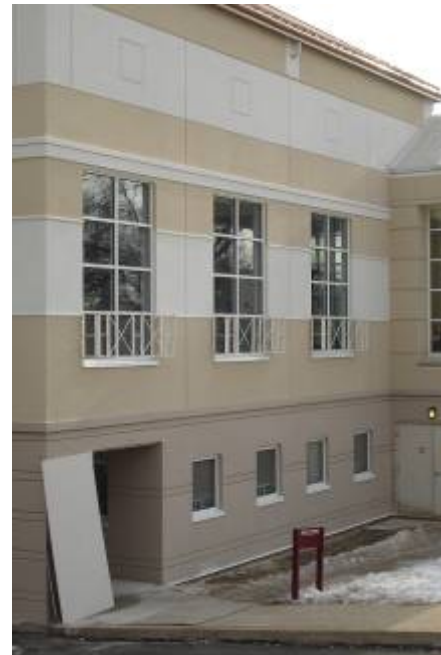
Figure 4. Field Investigation. Health Care Facility in Eagleville, PA

This project consisted of retrofitting and monitoring a health care facility. The structure had experienced water intrusion at numerous locations in the exterior walls and windows, which damaged studs and interior finishes.

Results. No sensors recorded any water intrusion, and neither the building's owner nor project personnel observed any evidence of water intrusion. Refer to the data tables in Appendix D.

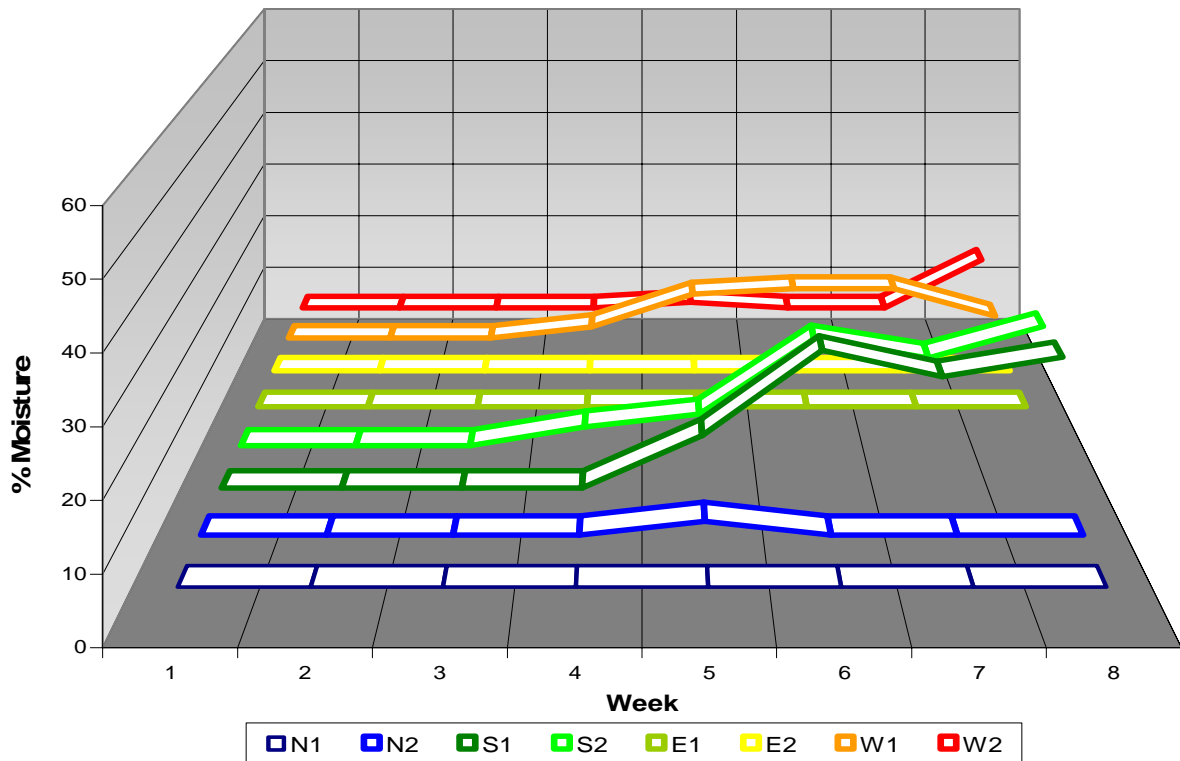
**Small-Scale Pan Flashing: Exterior Weathering
Series 1**

Results. After five weeks, membrane wrinkling occurred in some of the mockups, allowing a small amount of water to intrude between the membrane and the substrate. WBD continued the series for another three weeks, and then terminated it due to water-intrusion caused by wrinkling. See Appendix A.
