Application of Traditional Materials in Non-Traditional Ways for Improved Housing Construction

Mervyn J. Kowalsky¹ and Gavin D. Wight²

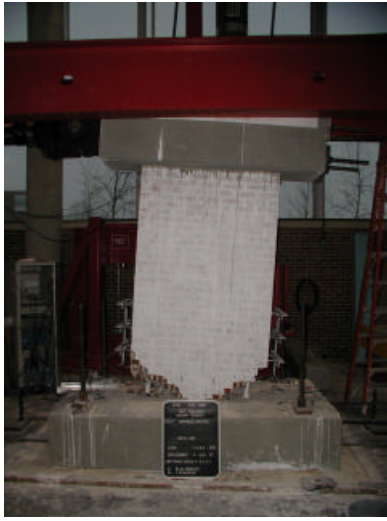
(a) Test 1: 6.5% Drift Ratio

Test unit one represents the 'control' specimen, and contained unbonded post-tensioning. The wall was grouted, and unconfined. During the course of this test, it was observed that the behavioral mechanism by which such a wall deforms is one of 'rocking', which is consistent with observations made by Laursen and Ingham (2000a,b) on post-tensioned concrete masonry walls. A photo of the test unit at 6.5% drift is shown in Fig. 2a, while the force-displacement hysteretic response is shown in Fig. 3a. From Fig. 2a, note the rather extensive damage to the compression toe regions, however, the remainder of the wall above this region remained largely crack free. The integrity of the masonry above the plastic hinge region is very important from the perspective of achieving a stable compression strut as will be noted in the discussion of tests four and five

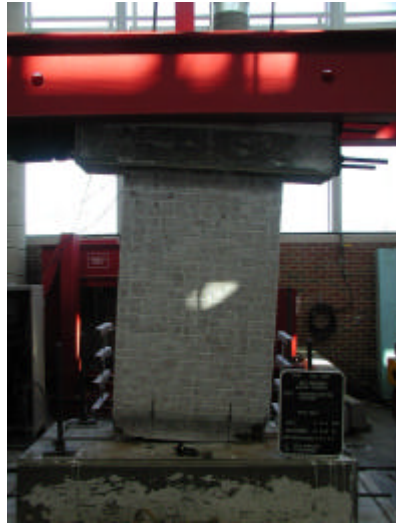
(b) Test 2: 6.5% Drift Ratio

Test unit two was identical to test unit one, with the exception of the addition of galvanized steel plates to the mortar bed joints in the bottom five courses of masonry. Application of confinement plates to masonry was first proposed by Priestley and Bridgeman (1974). The initial behavior of the test specimens was identical to that of test unit one. Initial crushing was noted at the same drift ratio of 0.5%. Beyond initial crushing, however, the behavior of the wall changed dramatically. Whereas unit one started significant strength degradation after 3.75% drift, the confinement of unit two stabilized the compression toe region allowing the wall to achieve a drift ratio of 10% without significant strength degradation. By stabilizing the compression toe region, the diagonal compression strut was able to sustain much higher levels of lateral deformation until finally, the compression toe region degraded, forcing the compression strut resultant outside of the confined region at a drift ratio of 11.3%. Fig. 2b represents the test specimen at a drift ratio of 6.75%. Compared to test unit one, very little damage is noted in the compression toe regions. The test specimen at 11.3% drift ratio is shown in Fig. 2c. The force-displacement hysteretic response is shown in Fig. 3b. Note the very stable loops with little residual deformation or loss of strength. The overall energy dissipation is rather low, consistent with the observation of test unit one.

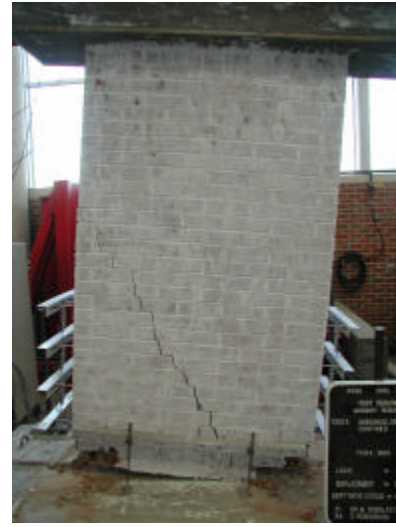
(c) Test 2: 11% Drift Ratio

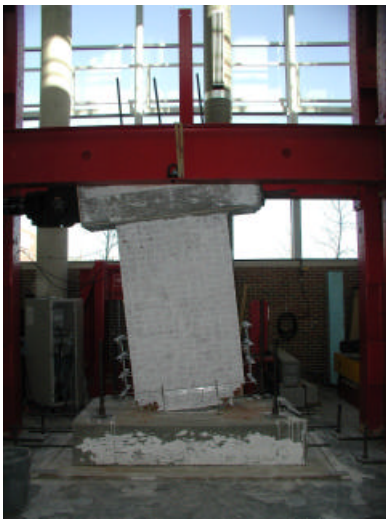
(d) Test 3: 6.5% Drift Ratio

The purpose of test unit three was to investigate the possibility of increasing the energy dissipation while retaining the desirable characteristics of little residual deformation of walls one and two. This test unit was identical to test unit one with the exception of the presence of mild steel to act as supplemental energy dissipation. Such an approach has been utilized for post-tensioned concrete structures (Priestley et al., 1999) and post-tensioned steel structures (Christopoulos et al., 2002), (Ricles et al., 2001) with some success. Fig. 2d represents a photo of the test specimen at a drift ratio of 6.5% which compares favorably to Fig. 2a for the control wall. The force-displacement hysteretic response is shown in Fig. 3c. When compared to the control wall, it is noted that significant strength degradation did not occur until a drift ratio of 5.0%. It is also noted that the energy dissipated in the walls is greater than that from the control specimen. Since the wall was unconfined, once the masonry starts to crush, there is a rather rapid degradation of strength. Application of confinement would certainly enhance the performance of this configuration, however, the added benefit may not outweigh the added effort for designing and constructing this configuration.

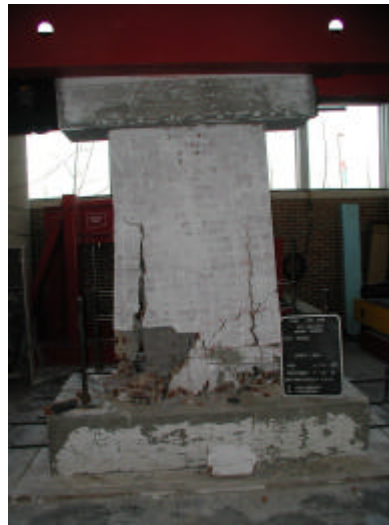
(e) Test 4: 3.75% Drift Ratio

The goal of test four was to most closely mimic the behavior of a conventionally reinforced wall. In doing so, the PT bars were fully bonded along the length of the wall after applying the PT force. Although it was expected that this wall would be damaged more than the unbonded walls, it was still expected to achieve similar deformation capacity. Unfortunately, that was not the case. Unlike the previous three walls, in addition to the base crack, minor flexural cracks due to the bond stresses between PT steel and masonry occurred at a drift ratio of 0.2%. These cracks were spaced at 250mm. Further loading resulted in masonry crushing at 1.0% drift. Soon after, at a drift ratio of 1.75%, vertical cracks were noted at the positions of the PT bars. These cracks occurred due to exceedance of the bond stress capacity between PT duct and surrounding grout. As the bond stresses increased resulting in vertical cracks, the behavioral mechanism started to shift away from flexural deformation back to the rocking mechanism observed in the previous three tests. Significant strength degradation was noted after 3% drift ratio, and at a drift ratio of 3.75% (Fig. 2e) damage was extensive in the wall. Due to this rather extensive damage, the diagonal compression strut was unable to stabilize, resulting in wall failure. The force-displacement hysteretic response for the wall is shown in Fig. 3d, and although there is higher energy dissipation than the control wall, the level of damage, reduced deformation capacity, and quick loss of strength rendered the performance of this wall poor.

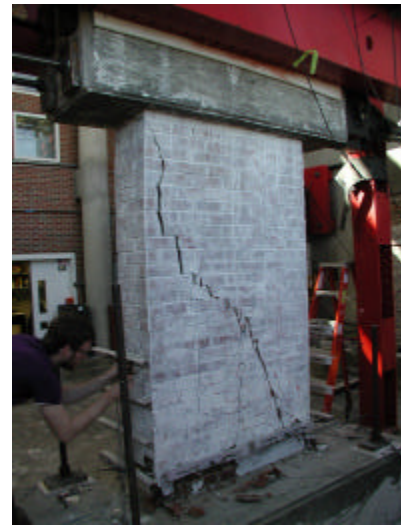
(f) Test 5: 1% Drift Ratio

The final test of the series was the simplest to construct, and the motivation for this test stemmed from simplicity of the configuration. Unfortunately, this turned out to be the poorest performing configuration. Although it behaved initially just as tests one through three, this configuration suffered a diagonal shear failure on a plane parallel to diagonal compression strut at drift ratio of only 1% (Fig. 2f). Due to the lack of a grouted core, it became impossible for a diagonal compression strut to form in the wall, and as a result, the rocking deformation was not achievable. Laursen and Ingham observed similar behavior in partially grouted concrete masonry walls (Laursen and Ingham, 2000a,b). The force displacement hysteretic response is shown in Fig. 3e. It is clear that such a configuration is not for anything but the lowest seismic regions.

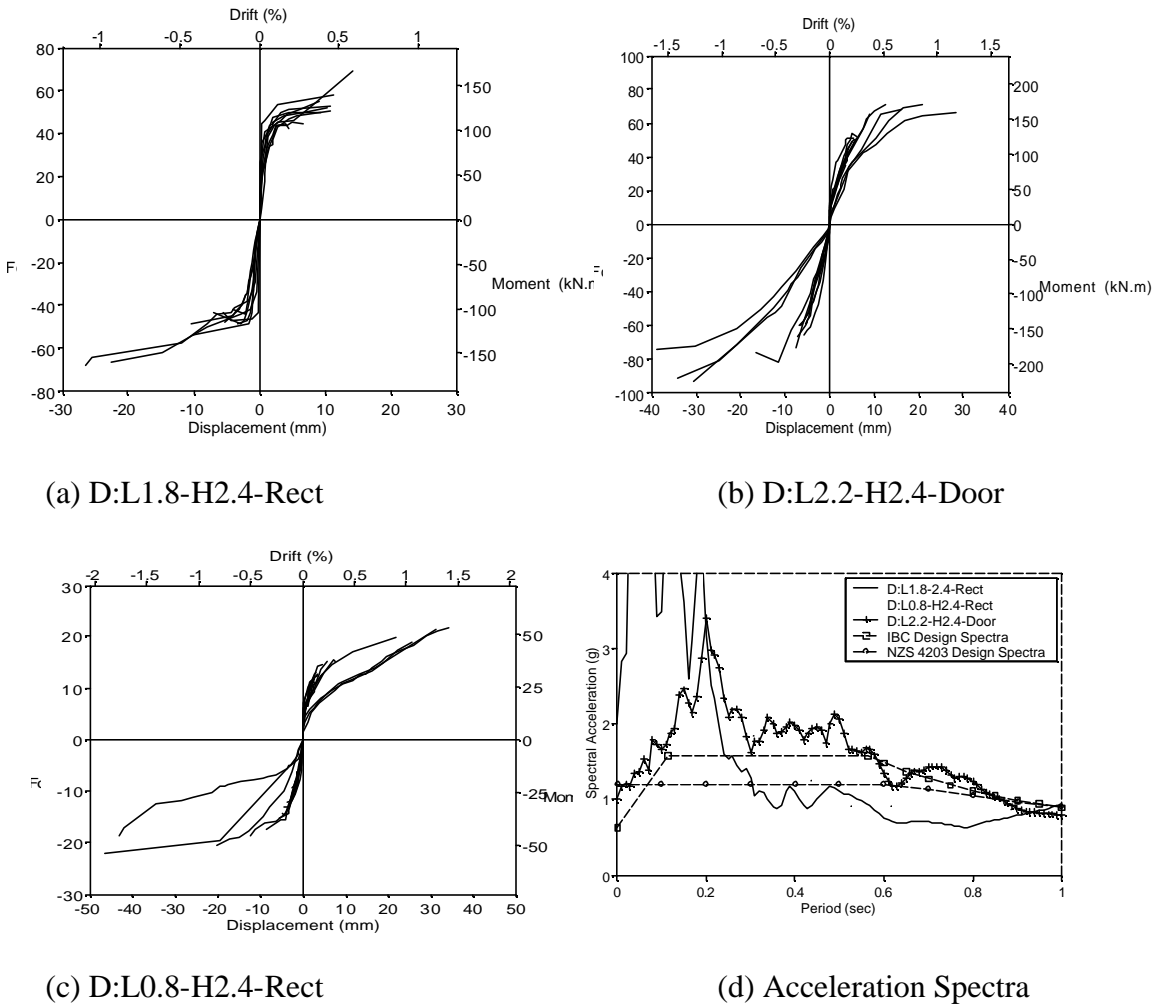
Figure 4. Force-Displacement Histories and Ground Acceleration Spectra for Walls

All walls were subjected to a variety of ground excitations of increasing intensity on the single degree of freedom shake table at NCSU. Fig. 5(d) shows the original ground acceleration spectra for the final run for each of the walls. To provide a means of comparison the design elastic spectra from the IBC (International Code Council, 2000) for San Jose, California and for flexible soil in a high seismic area in New Zealand (NZS 4203 1992) are also included. The additional seismic mass applied to the wall top was typically 2880 kg, which represents a loading of 3 kPa over a tributary length of 5 m. Fig. 5(a,b,c) show the force-displacement backbone curves for the three walls, which were derived using the equation of motion for a SDF system subjected to an external force. Recognizing that the velocity at the peak displacement must be zero, the force at peak displacement is simply the seismic mass multiplied by the total acceleration.

By plotting the force at the peak displacement of each wall oscillation throughout the duration of an earthquake record, a backbone curve can be fitted which encompasses all these points. Fig. 5(a,b,c) contain backbone curves for all ground accelerations run for each wall. It should be noted that any base sliding was subtracted from the top of wall displacements prior to plotting, and this was seen to be small compared with the top of wall displacements for all dynamic tests.

Initially a smaller seismic mass of 960 kg was installed on wall D:L1.8-H2.4-Rect and eight ground accelerations run. The wall sustained negligible damage and reached a peak drift of only 0.29%, therefore additional mass was added bringing the total up to 2880 kg. A further nine records were run, with the only damage sustained is shown in Fig. 6(a), being fine cracking of the mortar joint in the lower left wall corner. The force-displacement backbone curves for the nine runs with the larger mass are shown in Fig. 5(a), and indicate that all nine runs followed the same bilinear curve suggesting that there was no loss in wall strength or stiffness. Testing ceased due to mechanical problems with the shake table. This wall had an initial period of 0.11 sec, therefore Fig. 5(d) suggests that the wall was subjected to accelerations in excess of both design spectra.

For wall D:L2.2-H2.4-Door, the seismic mass was installed in two equal amounts of 1440 kg, one on top of each of the two wall panels, ensuring that the mass block did not stiffen the door lintel. The wall was subject to eleven records before testing was ceased due to considerable crushing of the wall panel lower corners, as shown in Fig. 6(b). Fig. 5(b) shows that the wall stiffness reduced throughout all the runs as a result of the accumulation of lintel cracking, but there was no significant loss of strength until the final run in the negative direction when the lower corner was crushed.

Wall D:L0.8-H2.4-Rect was subjected to thirteen ground excitations before testing ceased due to splitting of the repair mortar in the lower wall corners. Fig. 5(c) shows that the wall maintained initial strength and stiffness out to a drift limit of approximately 1% before corner crushing resulted in reduced stiffness for the final three ground excitations. Wall strength was not seen to decrease until the wall reached a drift of 2.0% in the negative direction and corner splitting occurred.
