## 4.2 TASK 2 – FULL-SCALE ROOF-TO-WALL CONNECTION SYSTEM TESTS

### 4.2.1 Objective

The objective of Task 2 was to measure and compare the lateral (parallel-to-wall) performance of full-scale roof-to-wall connection systems constructed with conventional common nails, pneumatic nails, and metal connector hardware. The nailing schedules included the current building code requirements for conventional residential construction [31][32] with interpretations representative of the field framing practices. Common and pneumatic nails were investigated. Results were used to evaluate capacity-based design procedures for analysis of nailed connections. Based on the test results the scope of the minimum prescriptive provisions for roof-to-wall attachment was determined for a selected building configuration and loading condition.

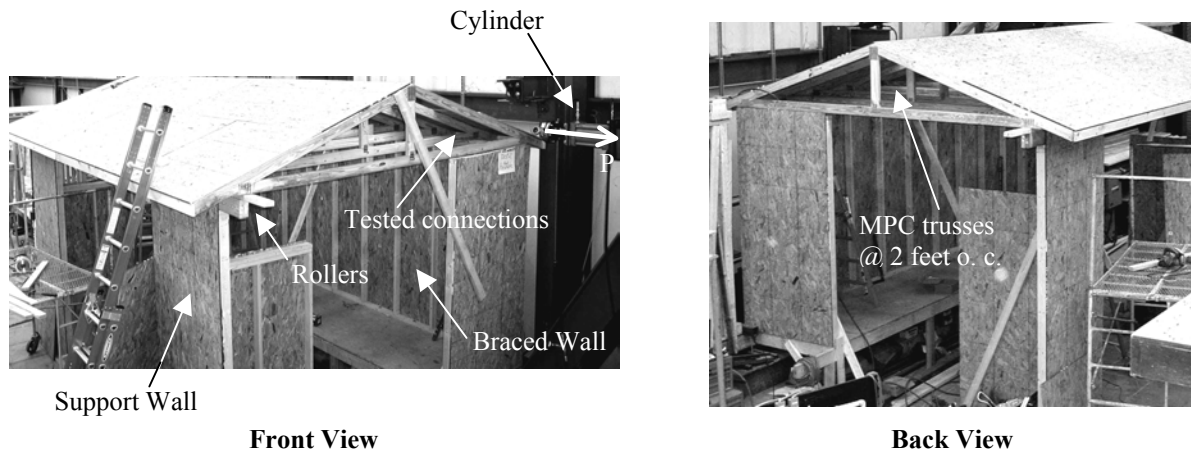
**Figure 9**  
**Roof-to-Wall Connection System Test Setup**

Six full-scale roof-to-wall connection system tests were conducted. Table 14 describes the test specimen configurations and Table 15 summarizes the materials, construction, and fastening schedules. Figure 9 shows the test setup.

Each test specimen included a 12-foot-wide by 20-foot-long roof assembly framed with eleven prefabricated 12-foot-span metal plate connected (MPC) wood trusses spaced at 2 feet on center and sheathed with 7/16-inch-thick OSB panels. One side of the roof assembly was supported by a 20-foot-long braced wall anchored to a support steel platform. Four-foot-long corners were built on each end of the wall. A hold-down device was installed at the uplifting wall corner for tests 5 and 6. The opposite side of the roof assembly rested on a reaction wall anchored to the concrete floor. The walls were framed with 2-inch by 4-inch nominal size SPF lumber and sheathed with 7/16-inch-thick OSB. The braced wall was designed to have capacity greater than the tested connections and it was reused throughout all six tests. The bottom member of the shear wall double top plate was nailed to the studs and sheathing, whereas the top member of the

The trusses were attached to the top plate of the braced wall according to nailing schedules specified in Table 14. Steel roller plates were placed between the roof assembly and the support wall on the opposite side to allow horizontal movement of the roof with minimum friction. A 1-inch by 6-inch nominal size fascia board was nailed to the plumb-cut ends of the truss top chords on both sides of the roof assembly to provide a rotation restraint for individual trusses.

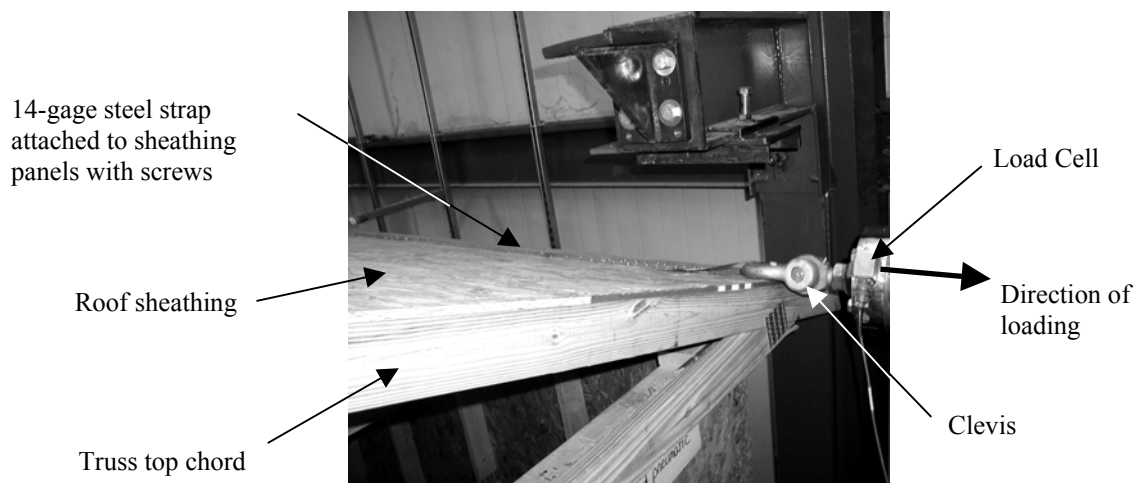
**Figure 10**  
**Loading Steel Strap Attachment**

Load was applied to the roof assembly through a 14-gage steel strap which was attached to the sheathing roof panels with screws (Figure 10). The screws were installed in the intervals between the trusses so that there were no additional fasteners connecting roof sheathing and top chords of the trusses. The use of the flexible steel strap minimized the effects of the boundary conditions imposed on the roof system by the test apparatus. The strap was attached to a hydraulic actuator using a clevis. The hydraulic actuator was mounted on a steel reaction frame using a pinned connection so that the moment forces were not transferred from the specimen into the cylinder and from the cylinder into the reaction frame. Tension load was applied to the strap at a constant displacement rate of 0.3 inch/min and the test was run until the load decreased by a minimum of 30 percent from the ultimate value. Load was measured with a 100,000 lb rated capacity electronic load cell positioned between the strap and the hydraulic actuator.

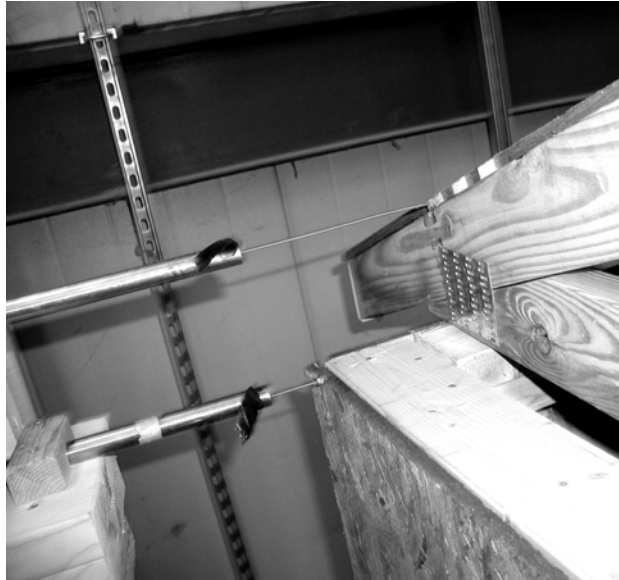
**Figure 11**  
**LVDT Setup (displaced position)**

Two linear variable displacement transformers (LVDT) were positioned on the opposite end of the test specimen to measure the deformation of the roof diaphragm relative to the braced wall (Figure 11). One LVDT was setup to measure displacement of the roof sheathing, and another was setup to measure the displacement of the top plate of the shear wall. The difference between these two readings was the total deformation of the roof relative to the wall top plate including

roof assembly translation, truss rotation, and sheathing panel slip. A computer-based data acquisition system was used to record the load and displacement measurements at a sampling rate of 1 Hz.

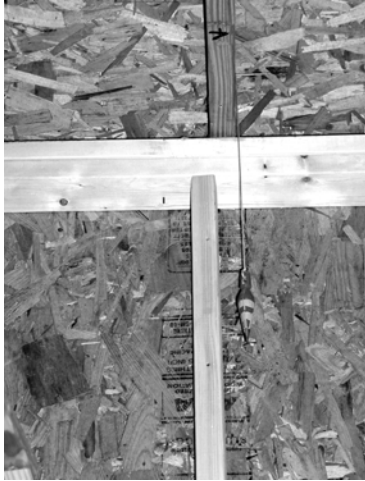
**Figure 12**  
**Horizontal Movement of Truss**  
(in initial position truss was aligned with stud)

Figures 12 through 15 exemplify the response and failure modes observed in test specimens 1 and 2. The trusses slid along the top plate of the braced wall with little out-of-plane rotation (Figure 12). The failure mode of toe-nailed connections was direction dependent and included wood splitting and tearing out on the tension side of the connection (Figure 13) and nail bending on the compression side of the connection. In one joint, the truss plate withdrawal resistance was exceeded and the top chord of the truss separated from the bottom chord (Figure 14). However, the truss plate failure of only one joint in two system tests (22 joints in total) indicates that toe-nails are the predominant weakest link in this type of connection under lateral loading.

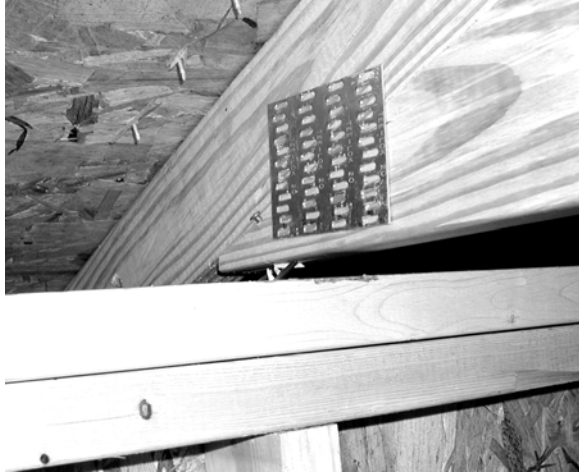
**Figure 16**  
**Truss Separation from Top Plate**  
**due to Nail Withdrawal**

Figures 16 and 17 show the failure modes for test specimens 3 and 4. In addition to the failure modes associated with specimens 1 and 2, the withdrawal of shorter 8d common nails from the wall top plate was observed. The nail withdrawal also caused uplift deformations of trusses from the wall top plate (Figure 16).

6. Because metal truss plates limit the area available for installation of toe-nails (Figure 16) and the beveled end of ceiling joist is susceptible to premature splitting (Figure 17), the toe-nailed truss-to-wall connection is not necessarily equivalent to conventional roof-to-wall connections that use roof systems assembled with rafters and joists rather than trusses. Therefore, further research is needed to develop prescriptive connection requirements for MPC trusses consistent with the use of three 8d common toe-nails with conventional roof systems.

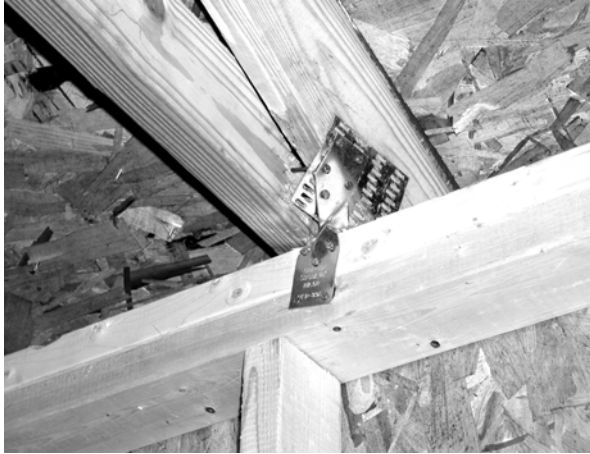
**Figure 18**  
**Truss Plate Separation**

Figures 18 through 22 exemplify the failure modes observed in test specimens 5 and 6. The hurricane clips changed the response and failure modes of the connections. Truss plate separation was more frequently observed (Figures 18 and 22) and trusses rotated out-of-plane (Figure 19). The degradation of hurricane clips was caused by excessive deformation of the body of the clip due to localized buckling of light-gage steel (Figure 20). One hurricane clip failed in tension along the cross section with two nail perforations (Figure 21).
