# **INTEGRATING PATH TECHNOLOGIES INTO MILITARY FAMILY HOUSING**

**Status Report on Housing at Beaufort/Parris Island, SC**

**April 2006**

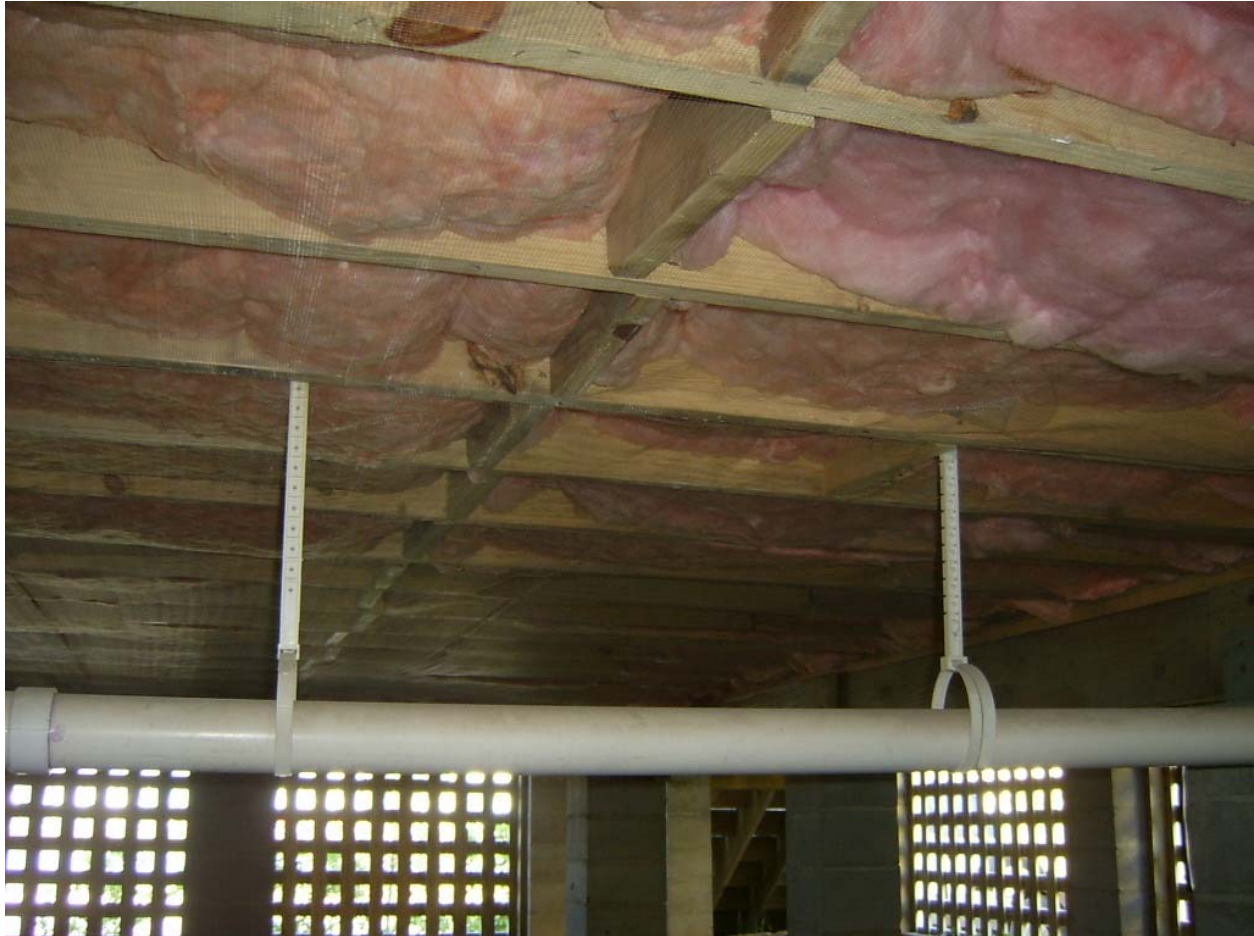
Figure 1 – Typical raised floor foundation

The new homes are a mix of three and four bedroom models for a variety of service ranks. Some of the homes are on slab-on-grade foundations. However, many of the homes are on raised floor foundations that are similar to a crawlspace except the floors are as much as six feet off of the ground. Rather than a continuous footing, the raised floor foundations are on concrete piers with a lattice wood covering around the perimeter as shown in Figure 1.
