LABORATORY AND FIELD EVALUATION OF PAN FLASHING/SILL PROTECTION AND WATER RESISTIVE BARRIERS

FINAL REPORT

April 2006

Williams Building Diagnostics, Inc.
945 Tennis Avenue
Maple Glen, PA 19002

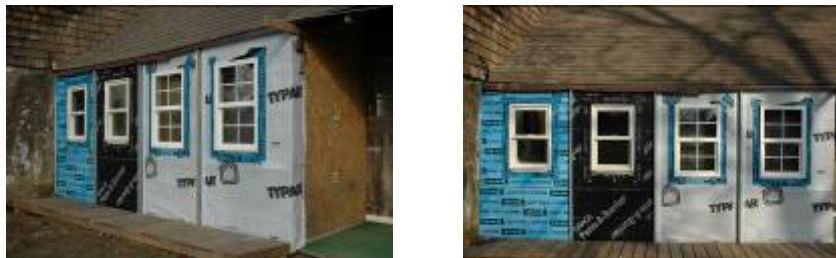
Figure 2. Full-Scale Window Wall Chamber

Construction of the mockup chamber included painted gypsum wallboard, wood studs, fiberglass batt insulation, OSB sheathing, and a wood floor deck, with a climate controlled interior. The steep sloped roof ended near the face of the exterior wall, with no projecting roof overhang. This allowed rainwater runoff to sheet down the exterior face of the mockup's wall and window assemblies.

On the west-facing wall, WBD installed four complete window/wall test assemblies: Panels A, B, C, and D. The panels offered four sets of typical conditions, by combining two different window installation methods with two different window types and two different WRB types (see Table 2).

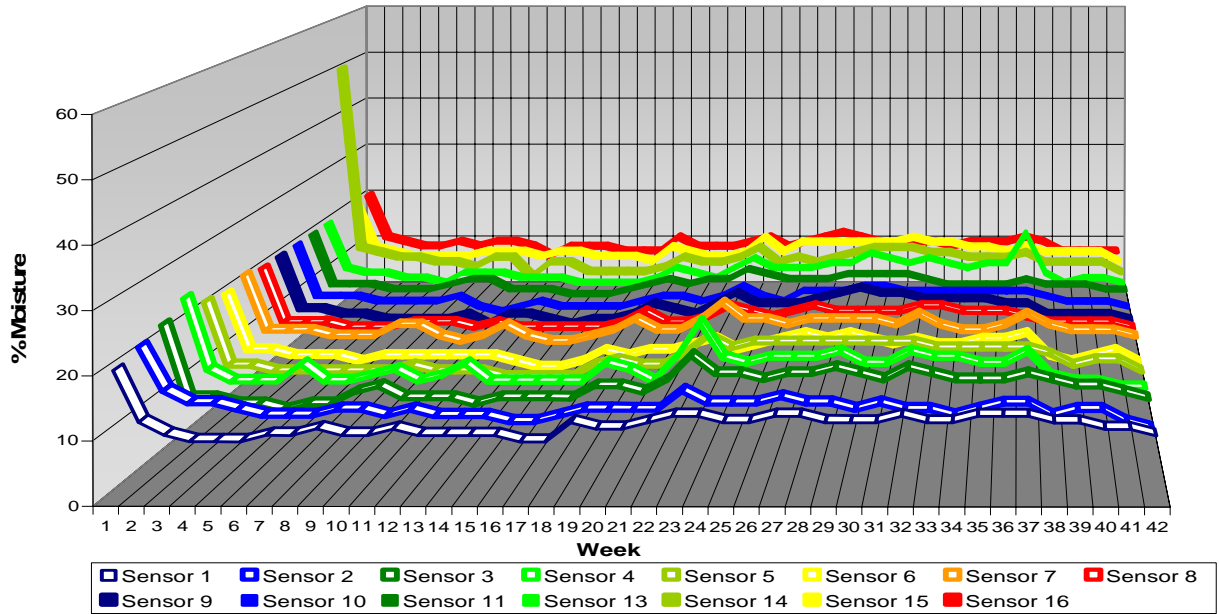
Eagleville, PA Field Evaluation
North Elevation

Sensor # 12 did not record data due to a malfunction. Accordingly, it is not included here.
