U.S. Department of Housing and Urban Development
Office of Policy Development and Research

***WATER INTRUSION EVALUATION
FOR CAULKLESS SIDING,
WINDOW, AND DOOR SYSTEMS
WATER INTRUSION - LABORATORY TESTING RESULTS***

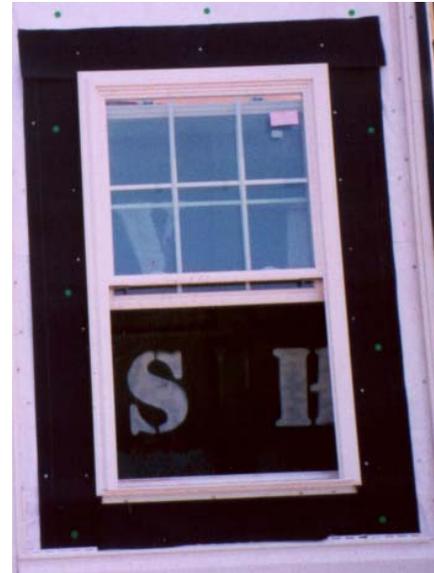
Figure 3
Flashing Detail

Test walls were constructed using best construction practices; studs on 24-inch centers, 7/16-inch oriented strand board (OSB) sheathing, exterior weather barrier and flange-mounted welded vinyl windows equipped with integral j-channels. Careful attention was paid to head, sill, and side flashing details. This was accomplished with 10-inch wide strips of 30-pound building felt attached with button-cap nails (see Figure 3). The bottom flashing was installed before the window so that the framing could be protected. Next, the window was installed. The window flanges were set in 100 percent silicon caulk. The side flashing was then installed so that it covered the window flange and overlapped the bottom flashing. Finally, a slit was cut in the weather barrier above the window. The felt flashing was inserted under the weather barrier and over the top window flange and side flashings. With the exception of the caulkless fiber cement test wall, the siding was installed as per manufacturer specifications.

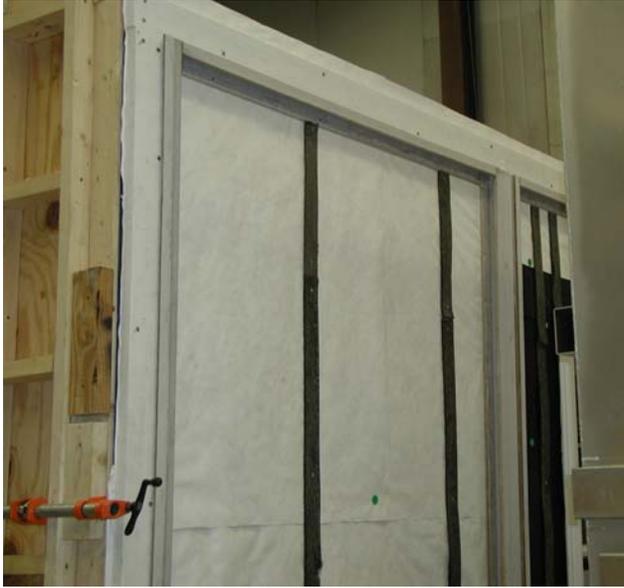
Figure 4
Drainage Plane

The caulkless fiber cement test walls utilized wood fiber/plastic composite corner posts and j-channels. These components are dimensionally and functionally very similar to vinyl siding corners and j-channel (Figure 4). When fiber cement manufacturers were consulted as to the feasibility of the caulkless system, they had several concerns. Their primary concerns were that the siding would absorb water through unprimed end cuts within the corner posts or j-channel. To address these concerns, several of the cut ends were protected with snap-on vinyl end treatments (Figure 5). Several other ends were not protected so that a comparison could be made.

Two, 2-inch wide strips of fiberglass composition roofing shingles, fastened with roofing nails, were used to form a 1/4-inch deep drainage plane (see Figure 4) for the fiber cement caulkless system with an airgap.

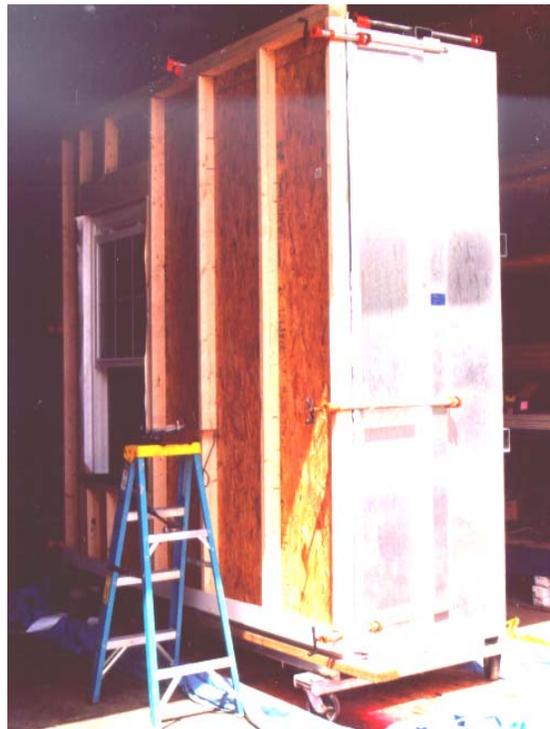
Figure 6
Wall Secured in Test Chamber

Once constructed, the test walls were inserted in the test chamber using a foam gasket to prevent leakage during the evaluation period (Figure 6).

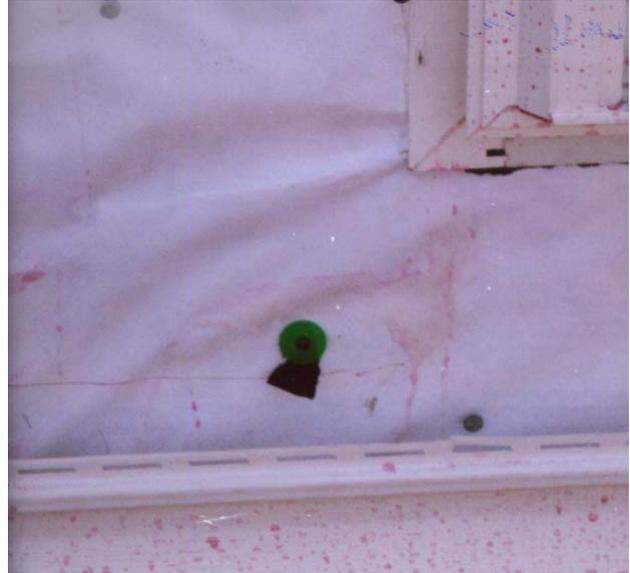
Figure 9
Vinyl Specimen

The vinyl-sided specimen allowed significant water intrusion. The primary leakage area was around the end treatments. Significant streaking was noted on the interior portions of the j-channel and split-corner post as well as the window’s integral j-channel (Figure 8). These visual observations are also supported by the results of the gutter collected water presented in Table 2. Significantly more water was collected on the window side of the wall. Some minor streaking was also noted at the intermediate splices in the siding on the clear wall side of the specimen (Figure 9).

The majority of the streaking was almost completely vertical. This confirms that the vinyl siding provides an unobstructed drainage plain.

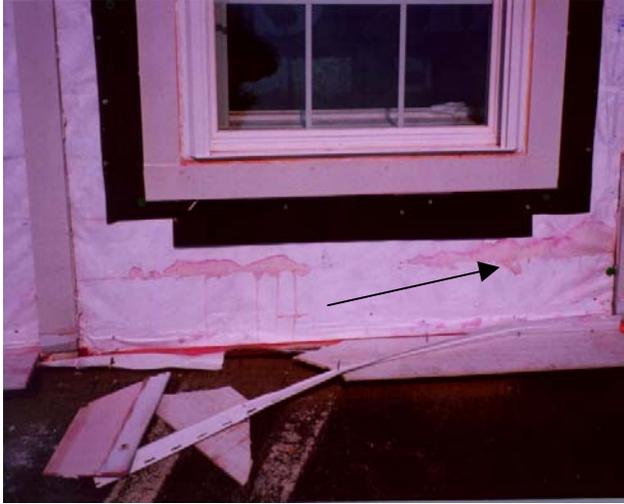
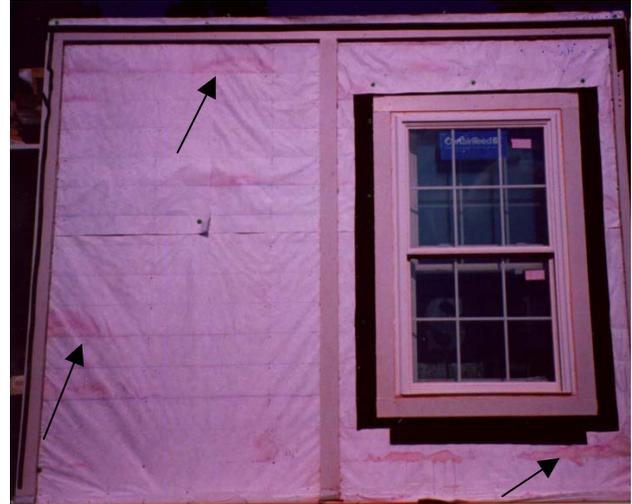
Visual inspection indicated that water penetrated to varying extents at the majority of the caulk joints. However, the majority of water intrusion appears to have occurred through the bottom of the laps of siding (Figures 10 and 11). This leakage path was more pronounced in this specimen when compared to either of the caulkless specimens (Figure 12). It is possible that the pressure difference between the front and backside of the siding was influenced by the caulk sealed areas. This could cause a greater pressure differential and concentration of air flow through less crack length areas. The high pressure difference and airflow rate could explain why water traveled up and over the siding laps. This would explain why this phenomenon did not occur on the caulkless systems.

Figure 10
Conventional Fiber Cement Specimen - Window

Figure 11
Conventional Fiber Cement Specimen - Clear Wall

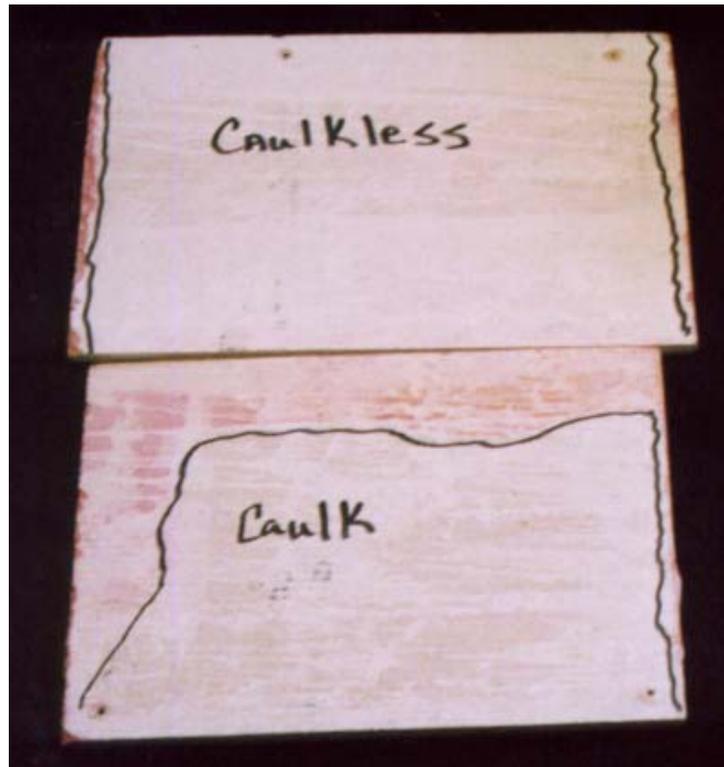
Figure 12
Fiber Cement - Staining on Back of Siding
(Extent of Staining is Outlined)

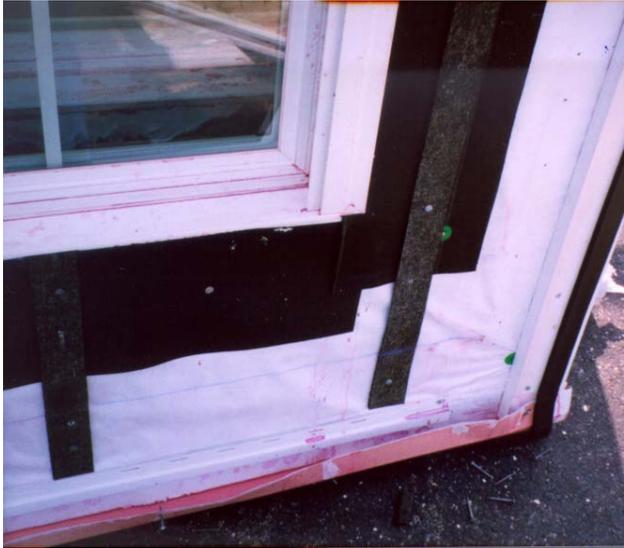
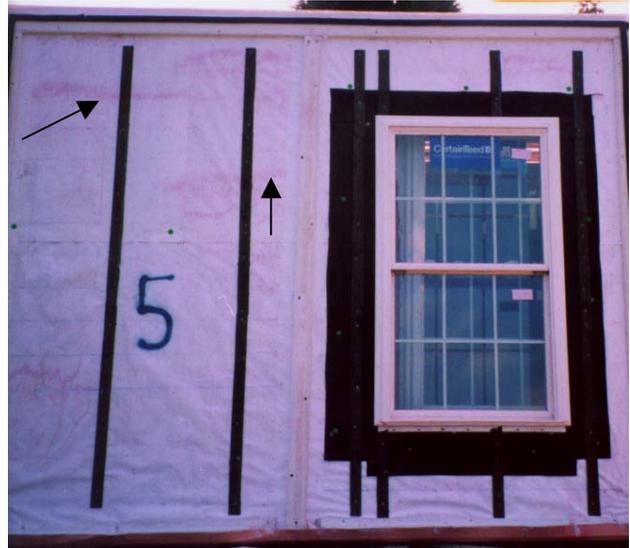
Both of the caulkless fiber cement samples performed very similar to the vinyl sided specimen. As with the vinyl sample, the corner posts and j-channel had significant vertical streaking (Figures 13 and 14). The vertical streaking indicates an unimpeded flow of water out of the wall system. This was expected on the specimen with the drainage plane, but not necessarily of the specimen without the drainage plane. The 1/4-inch-thick composite cornerpost and j-channel

appear to have created adequate separation at the edge details between the siding and weather barrier to allow the water to move freely.

Figure 13
Fiber Cement with Drainage Plane (Window)

Figure 14
Fiber Cement with Drainage Plane
